FIELD INVESTIGATION PHOTOGRAPH ALBUM

**OPERABLE UNIT NO. 7
(SITES 1, 28 AND 30)**

**MARINE CORPS BASE, CAMP LEJEUNE
NORTH CAROLINA**

JULY 29, 1994

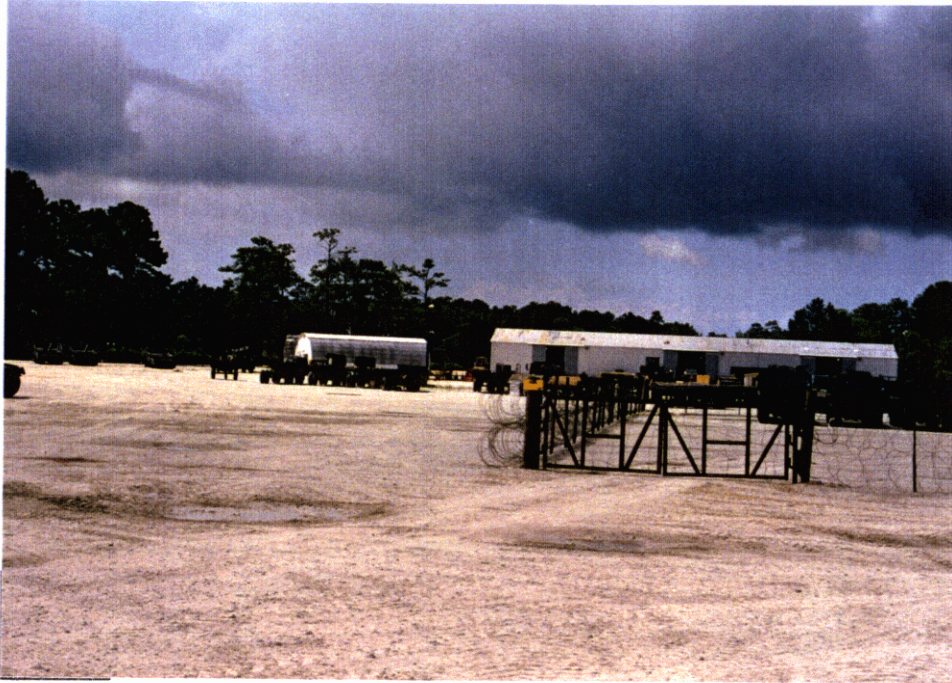
OU7.Site01.1994.01: This photograph was taken facing south from Main Service Road, across the Motor Transport Lot at Site 1.

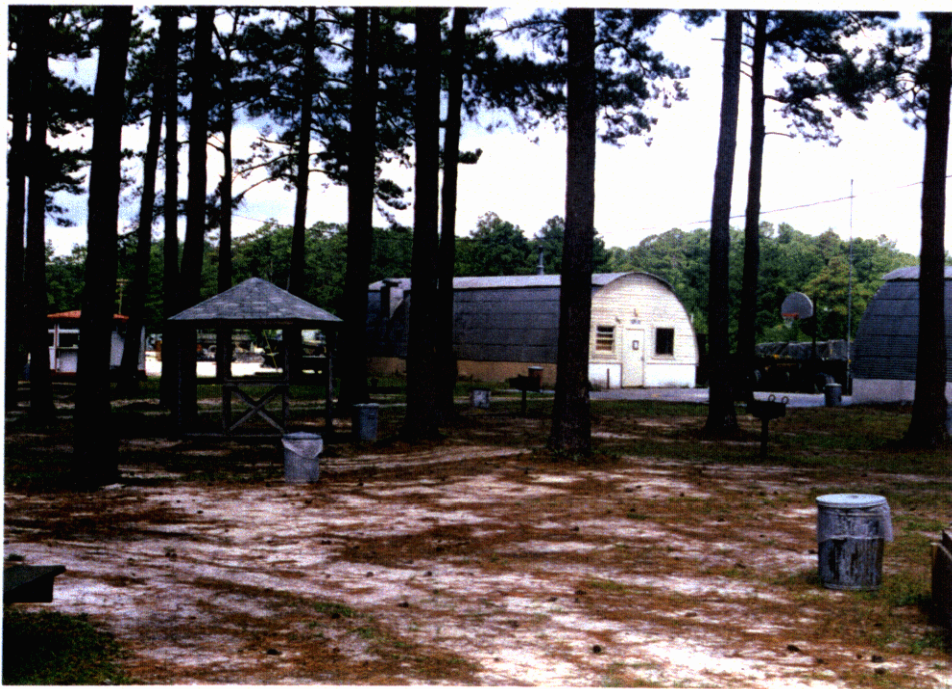
OU7.Site01.1994.02: This is the view from H.M. Smith Boulevard facing northwest across an adjacent picnic area, toward the Motor Transport Lot.

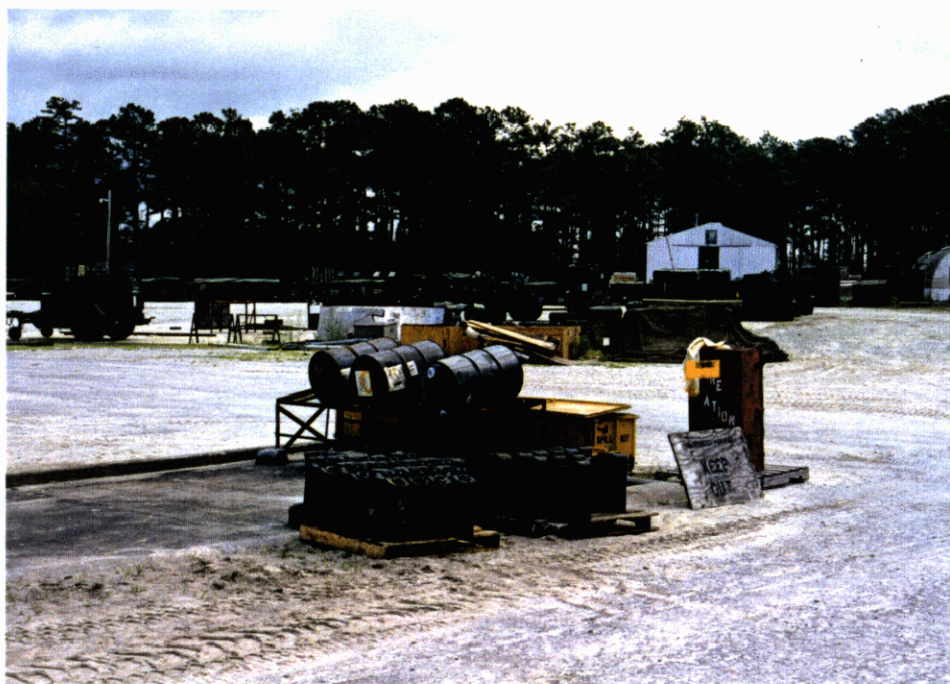
OU7.Site01.1994.03: The drums and containers, pictured in foreground, contain fuel and lubricants used to maintain vehicles and equipment.

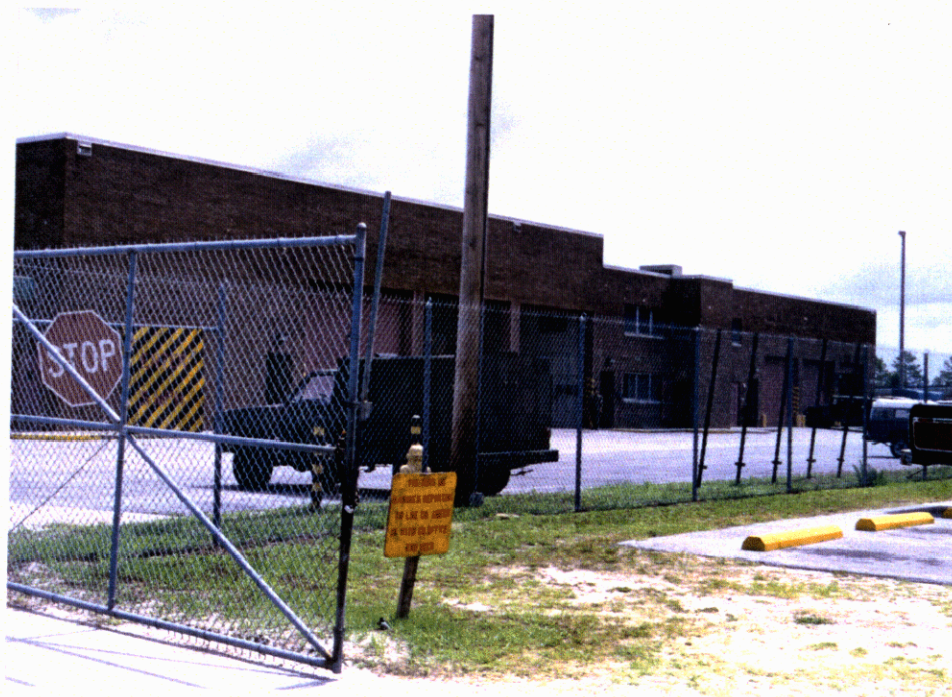
OU7.Site01.1994.04: Building FC-120, pictured here, serves as a transport vehicle and equipment maintenance facility for the Landing Support Battalion. The building is situated along the north side of Main Service Road.

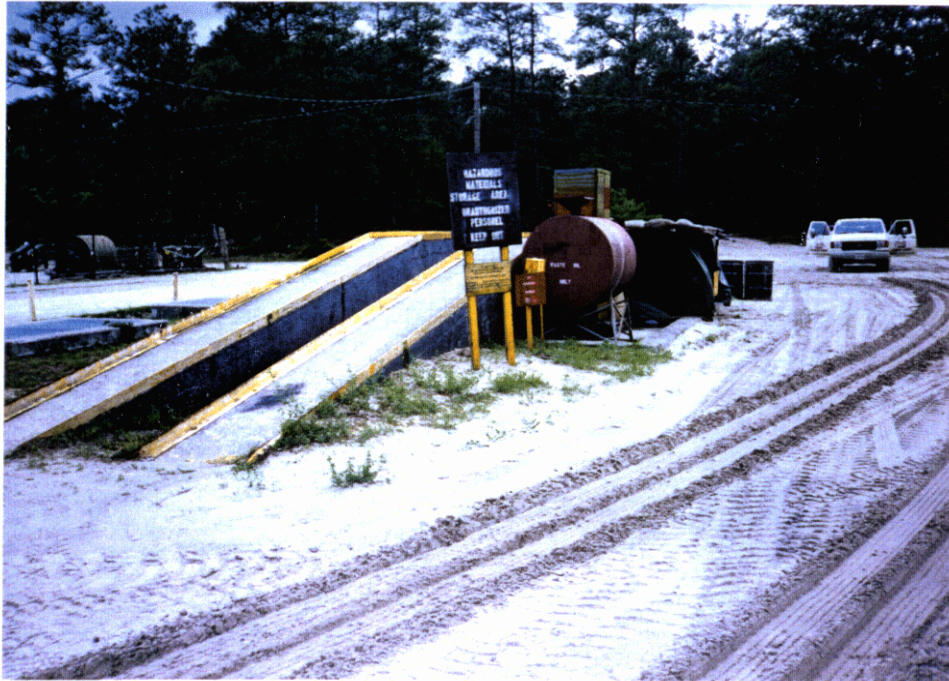
OU7.Site01.1994.05: This vehicle maintenance ramp and materials storage area are located on the south side of Main Service Road, adjacent to Building FC-739.

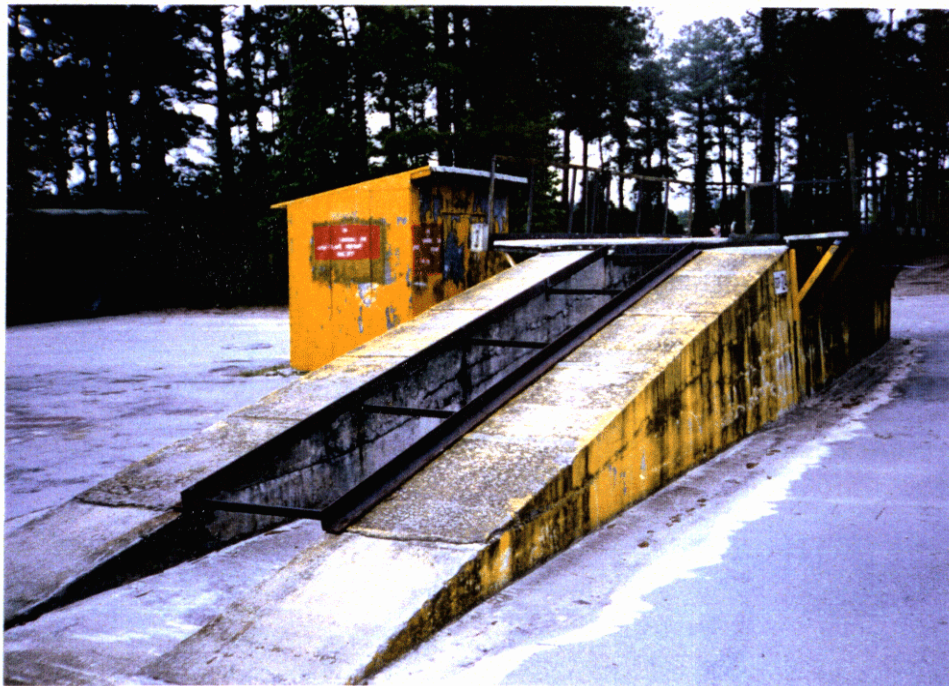
OU7.Site01.1994.06: This photograph shows another vehicle maintenance ramp and a materials storage locker also located within the southern half of Site 1.

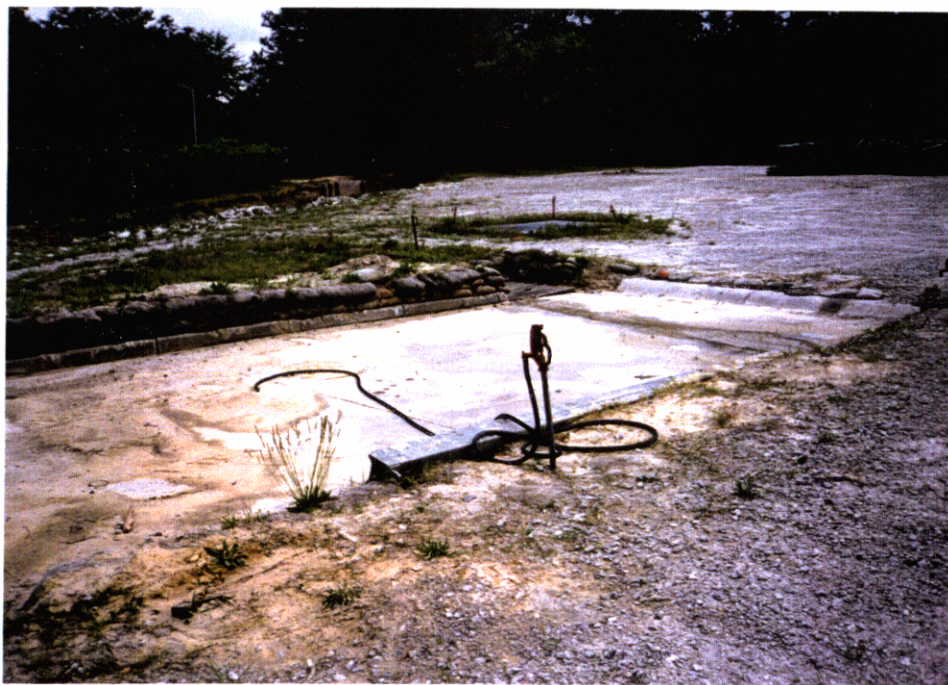
OU7.Site01.1994.07: This vehicle and equipment wash basin is located near H.M. Smith Boulevard on the south side of Site 1. Liquids from the wash basin flow into an oil/water separator (metal grate in background).

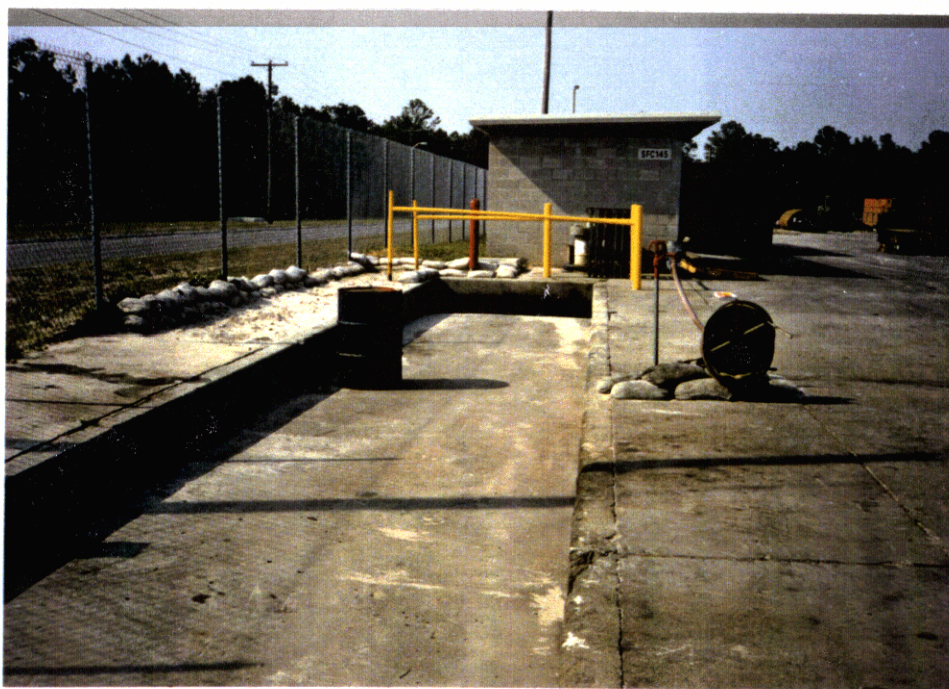
OU7.Site01.1994.08: This photograph was taken facing north from within the secured area surrounding Building FC-120. The liquids from this vehicle and equipment wash basin (in the foreground), are also fed through an oil/water separator (see photograph 07.01.1994.09).

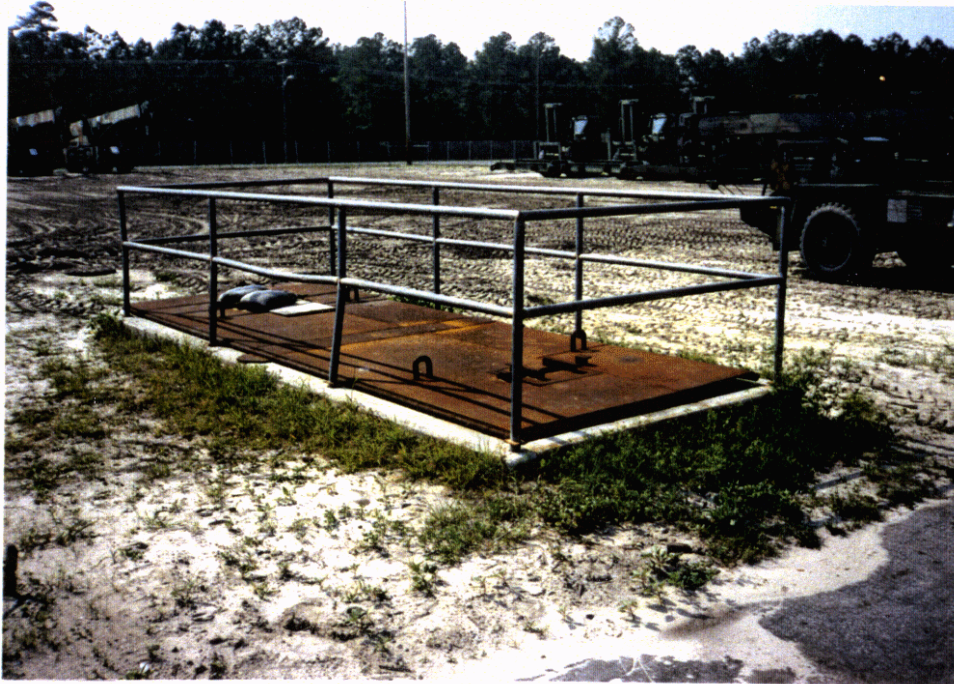
OU7.Site01.1994.09: This oil/water separator serves the Building FC-120 maintenance complex, on the northern side of Site 1.

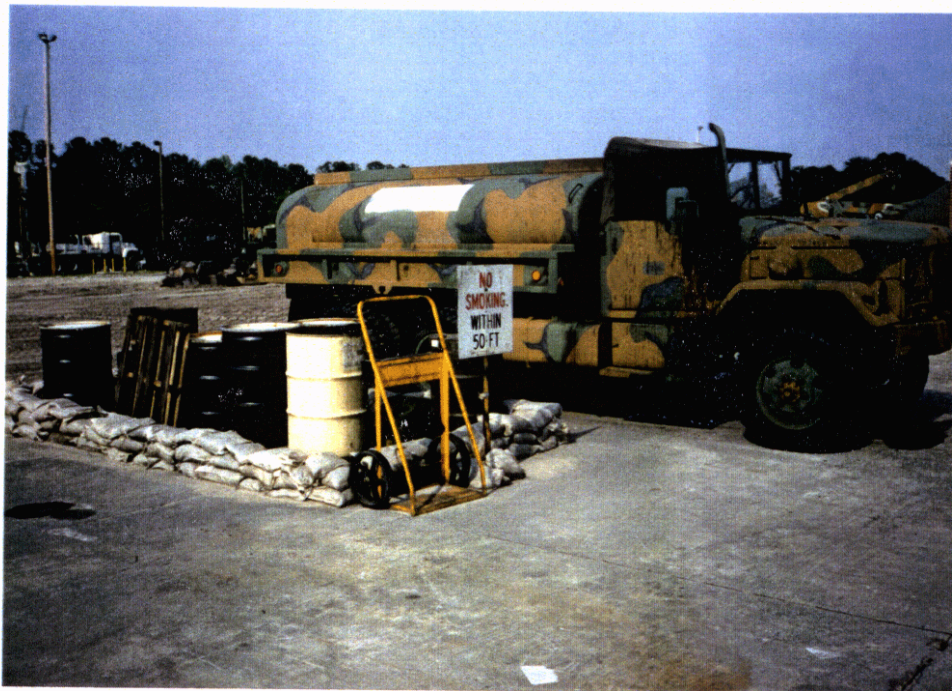
OU7.Site01.1994.10: This temporary storage area is used to store maintenance fluids. The storage area is located within the Building FC-120 complex.

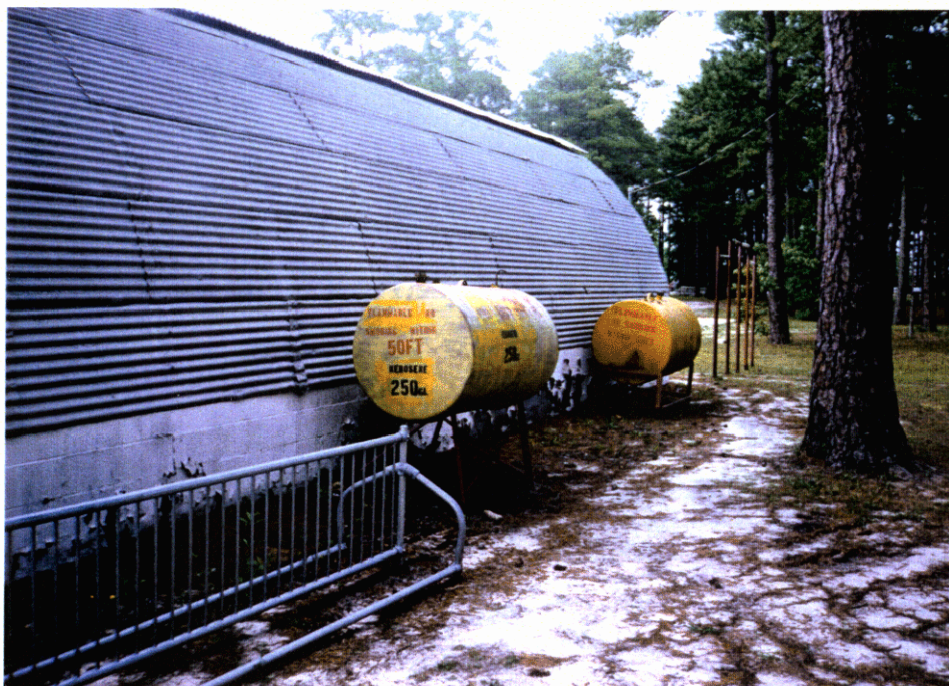
OU7.Site 01.1994.11: The two storage tanks shown are used to store kerosene for use as heating fuel. A number of additional buildings, located on the southern half of Site 1, use kerosene from similar tanks.

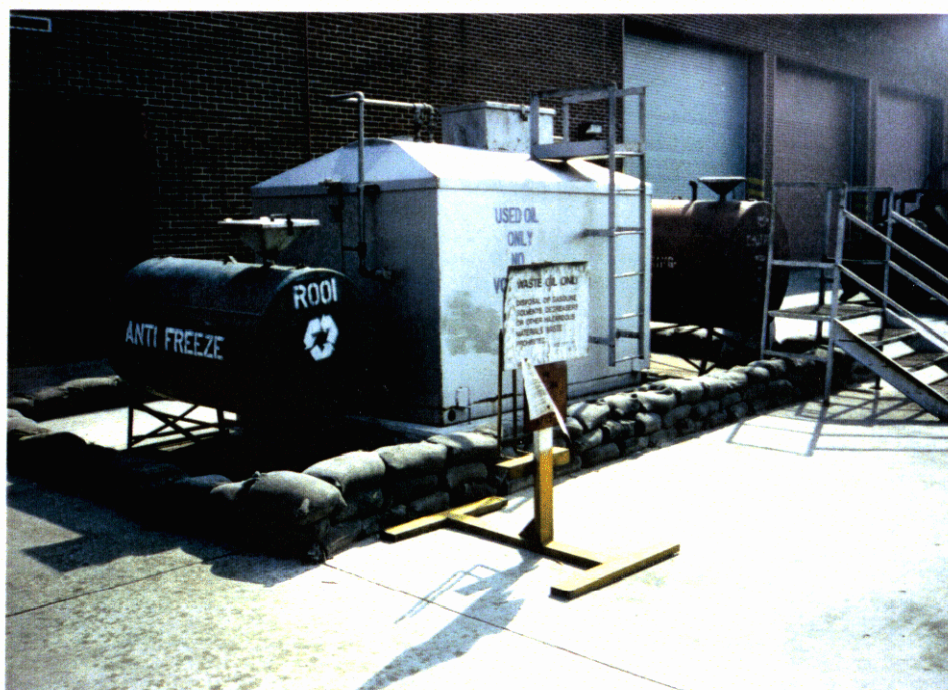
OU7.Site 01.1994.12: These three above ground storage tanks are used to store spent maintenance fluids. The tanks are located atop the site of a former 1,000 gallon underground storage tank (GTGS, 1993), adjacent to Building FC-120.

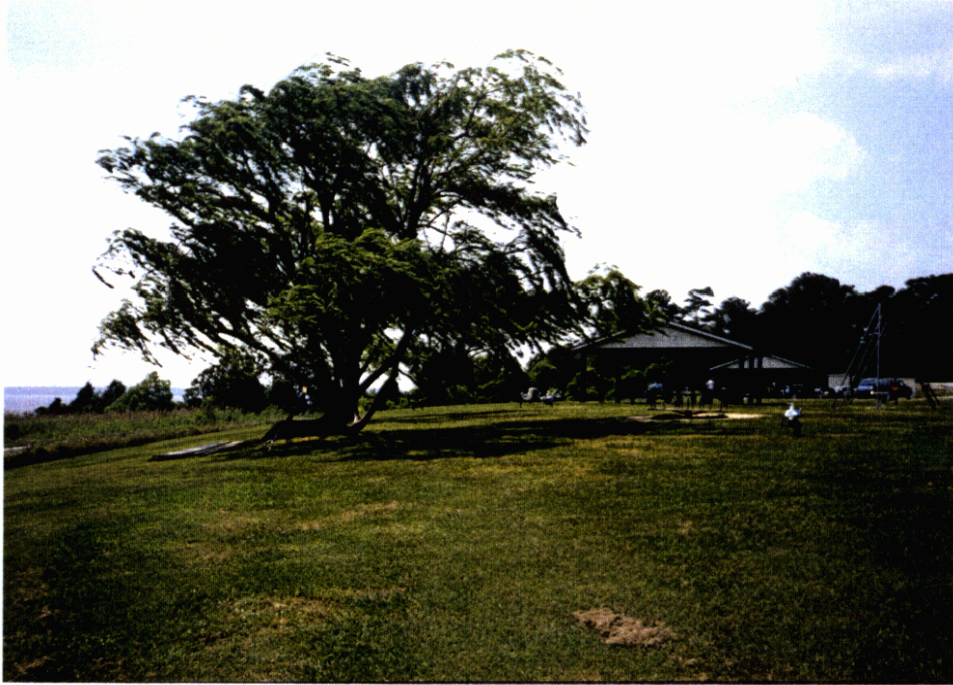
OU7.Site28.1994.01

This photograph was taken facing northwest looking toward the picnic pavilion area, on the western portion of Site 28.

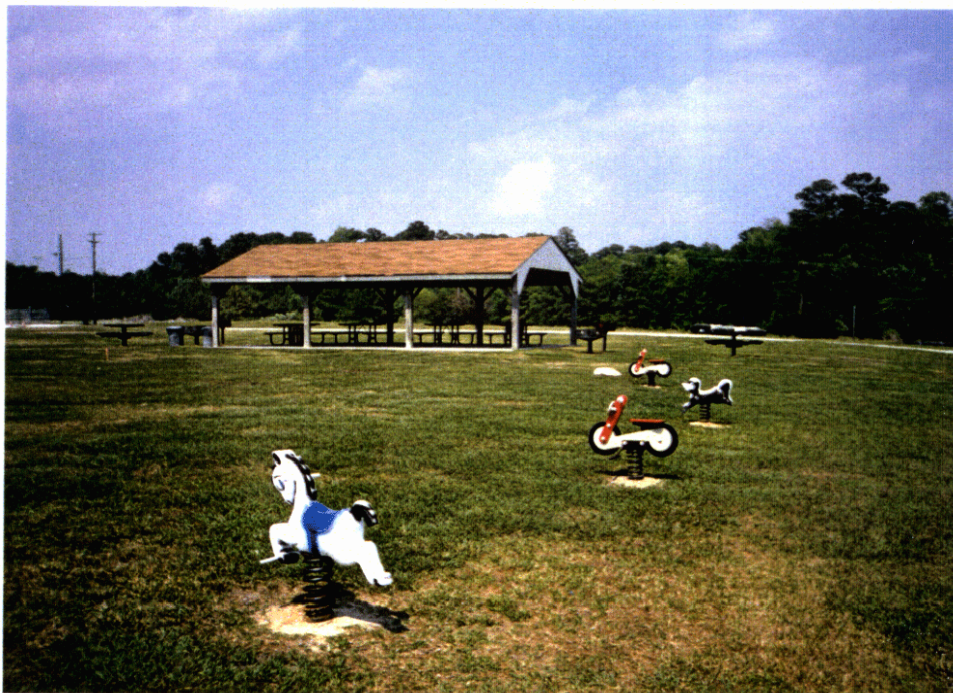
OU7.Site28.1994.02

This is a view of another picnic pavilion on the western portion of the site. Photograph taken facing east.

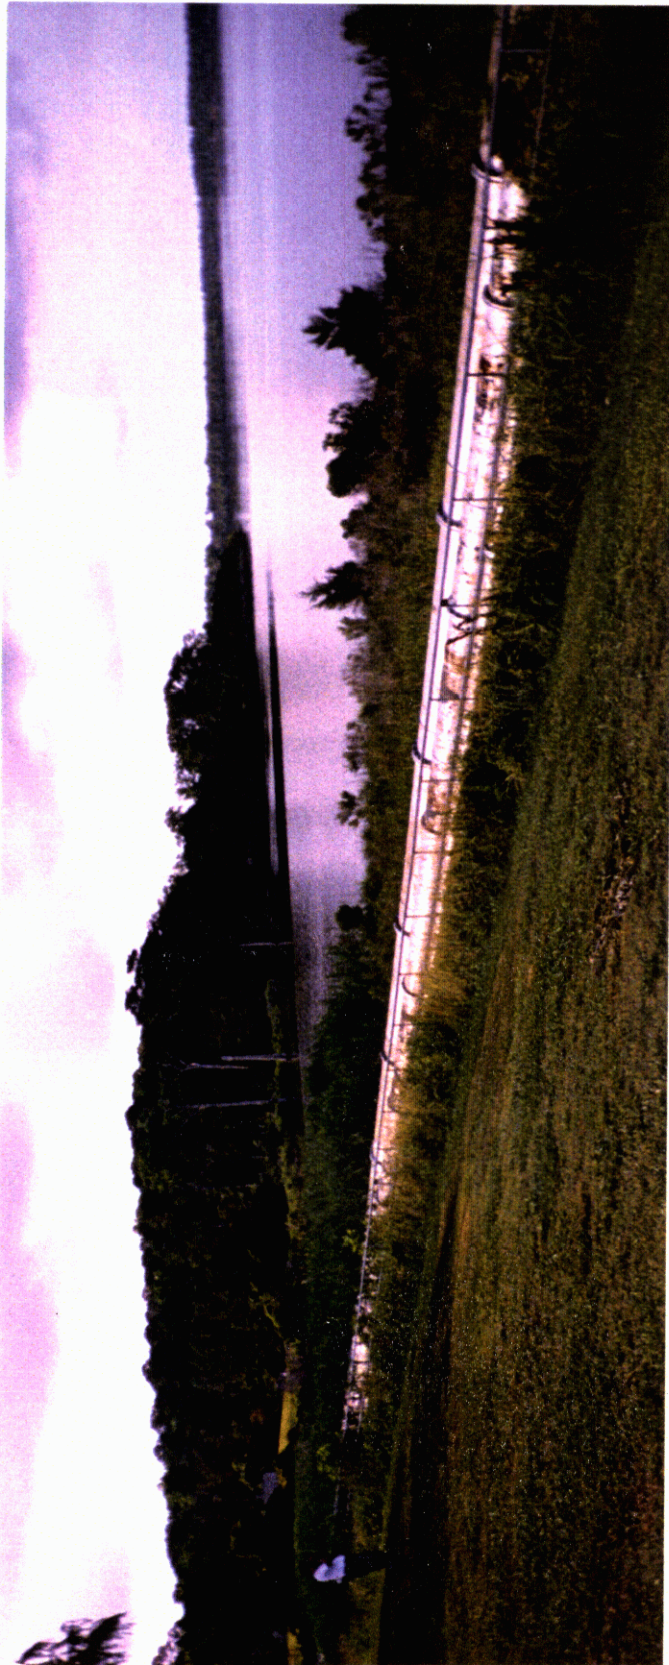
OU7.Site28.1994.03

Site 28 as seen
facing
southwest from
the western
picnic pavillion
area toward
the New River.

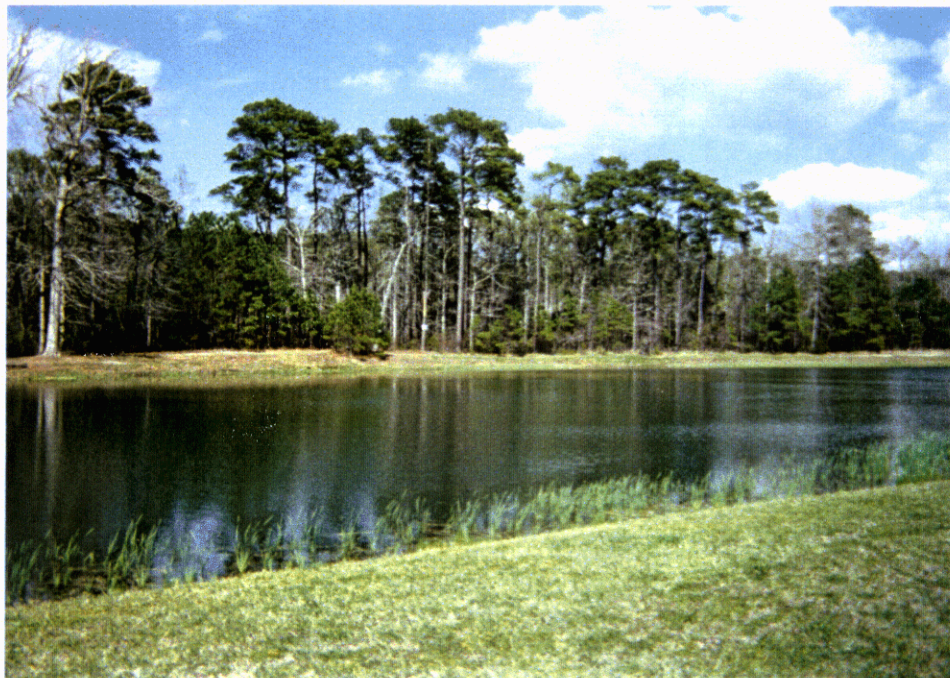
OU7.Site28.1994.04 Orde Pond, pictured here, lies on the eastern portion of Site 28.

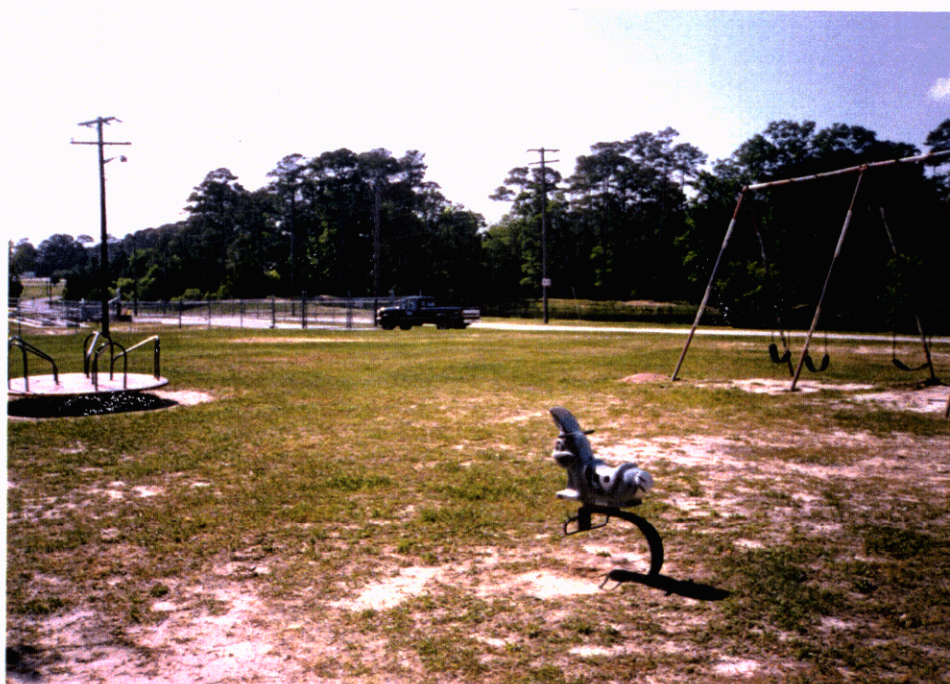
OU7.Site28.1994.05 This photograph was taken facing northeast, toward Orde Pond, across the eastern picnic pavilion area.

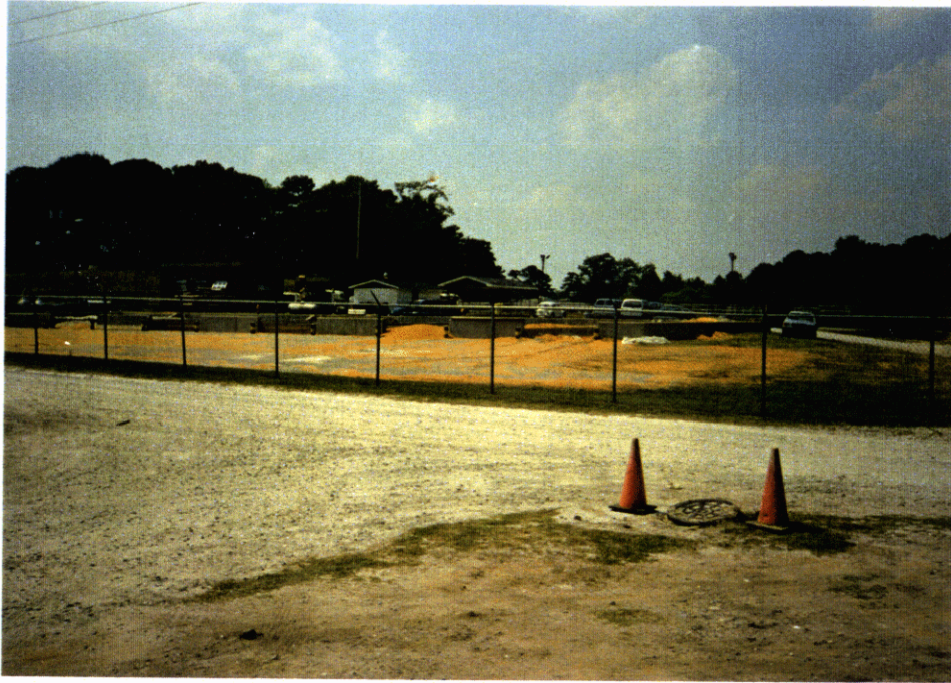
OU7.Site28.1994.06

The Mainside Sewage Treatment Plant (STP), extends from the western portion of the site across Cogdels Creek (see Photograph 07.28.1994.09).

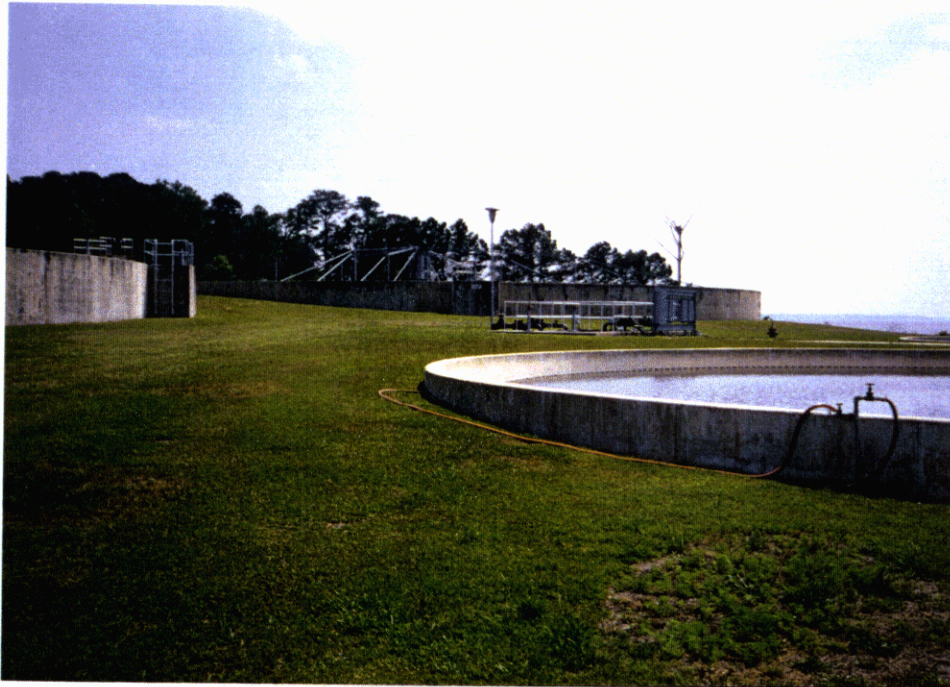
OU7.Site28.1994.07

This photograph was taken facing southwest from the Mainside STP clarifying pond area toward the New River.

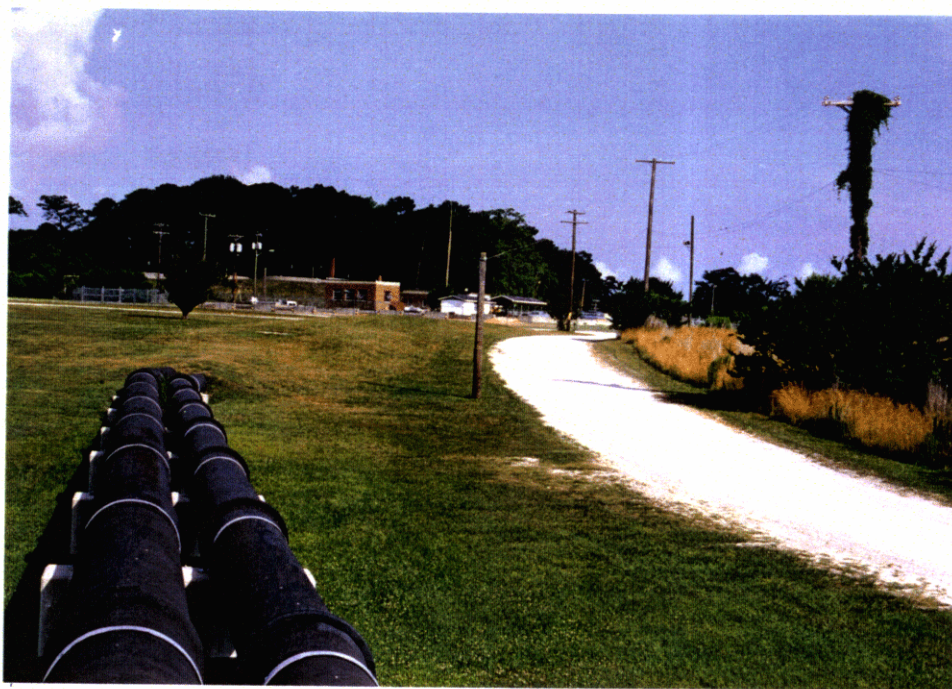
OU7.Site28.1994.08

This is a view of the Orde Pond gravel access road and two Mainside STP transmission lines.

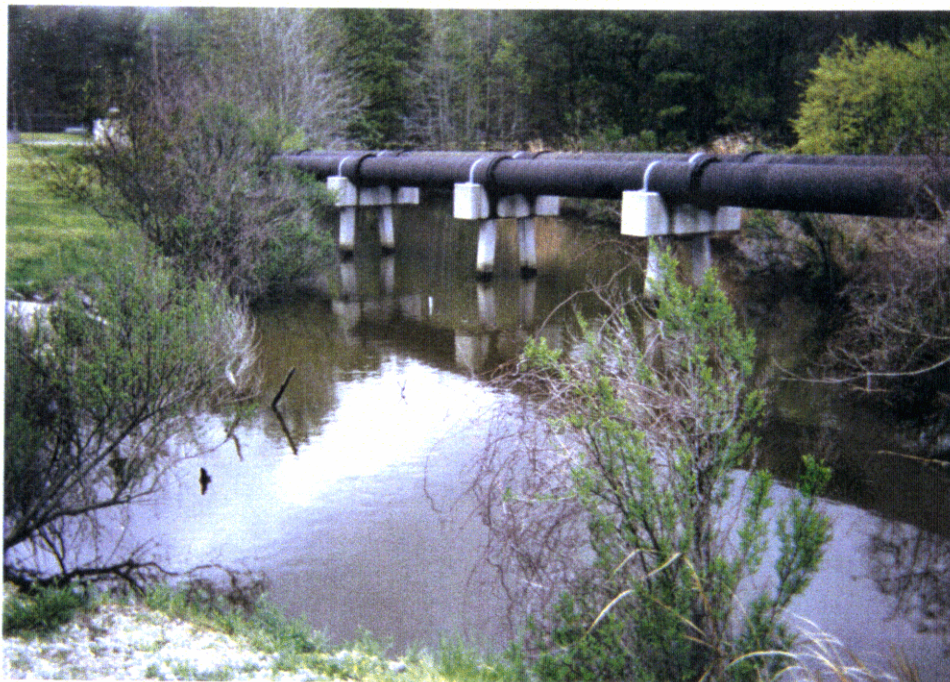
OU7.Site28.1994.09

The two transmission lines, pictured here, serve an aeration pond located at the easternmost extent of the Mainside STP facility. The transmission lines cross Cogdels Creek at this location.

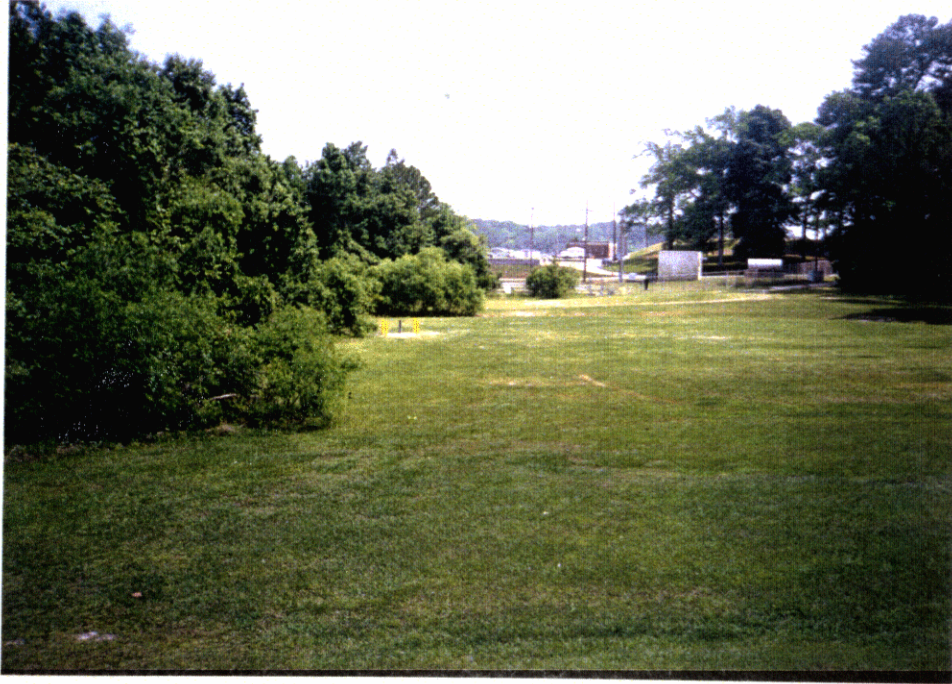
OU7.Site28.1994.10

This photograph was taken facing southwest from O Street, toward the Mainside STP.

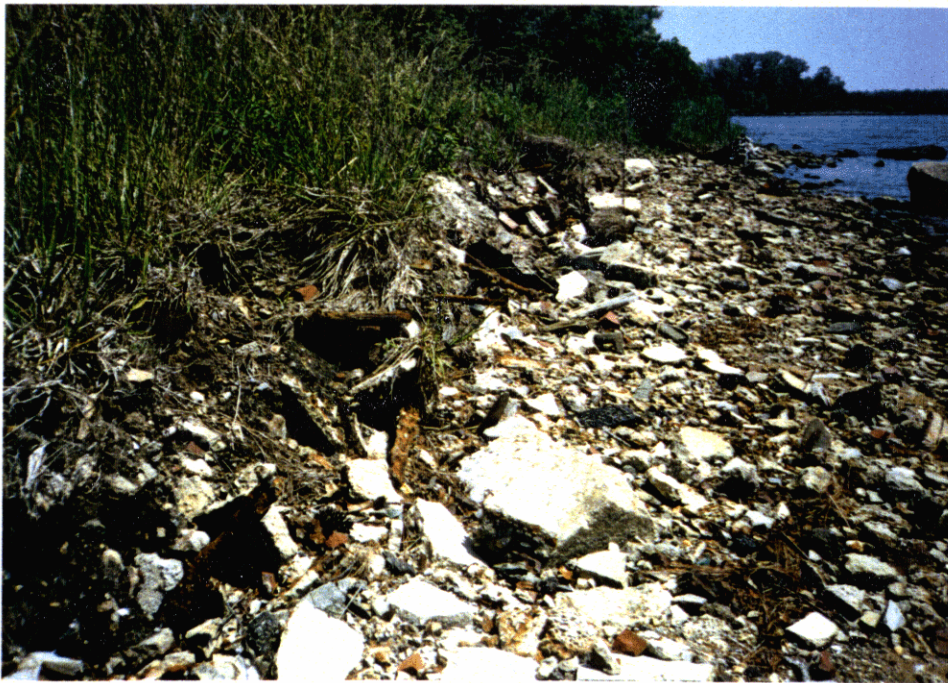
OU7.Site28.1994.11

Metallic debris, asphalt, bricks, and concrete rubble can be seen eroding from the cut bank along the New River.

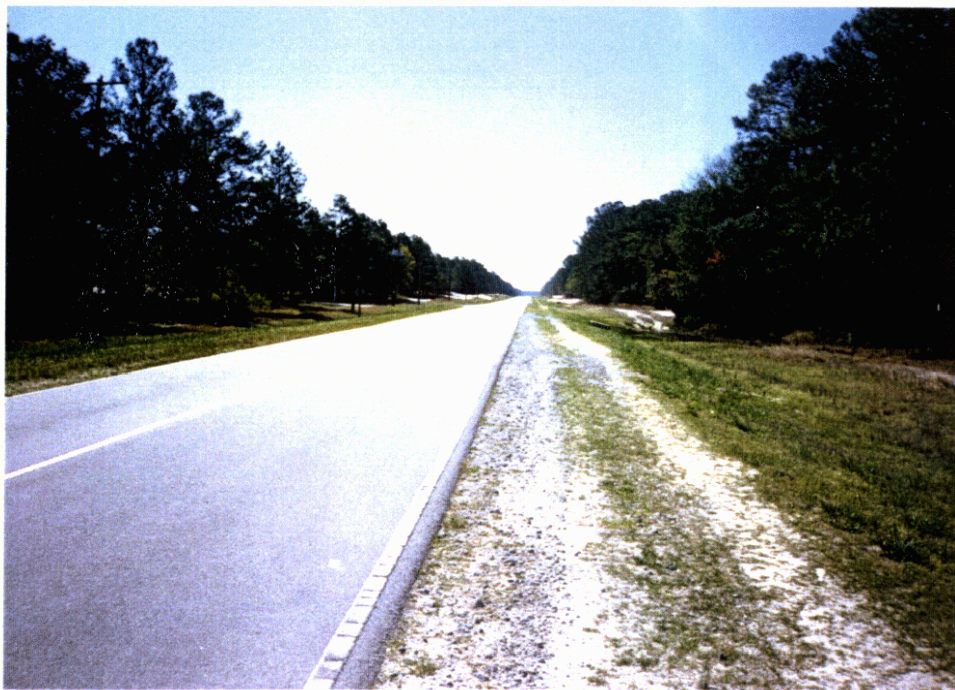
OU7.Site30.1994.01

This photograph was taken facing southeast from Sneads Ferry Road toward Site 30.

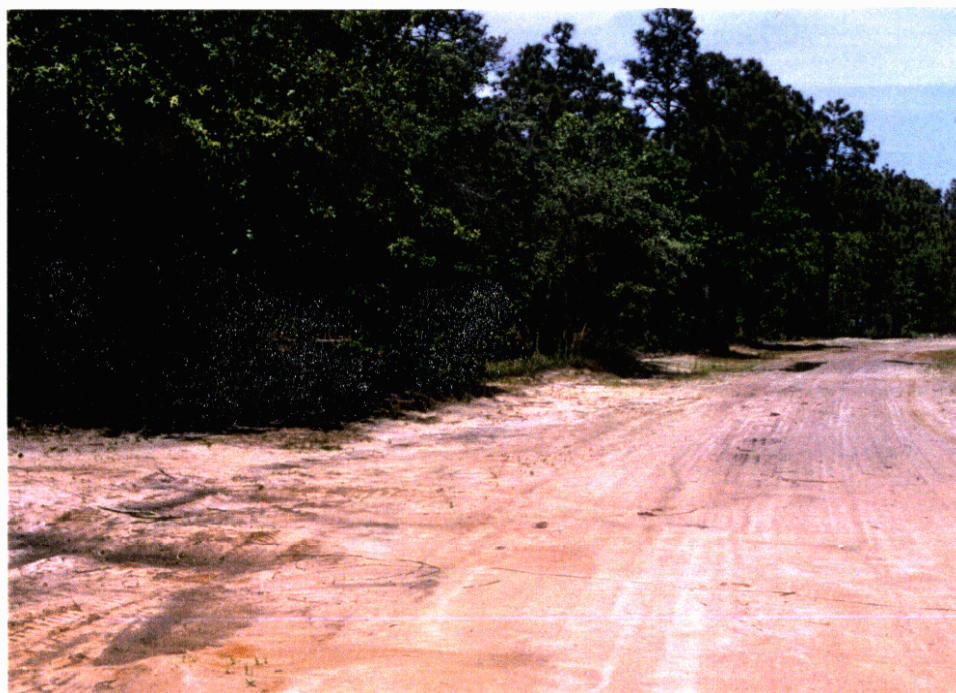
OU7.Site30.1994.02

This is the view from Sneads Ferry Road facing southwest toward the center of the site. The road leading to the site is unimproved.

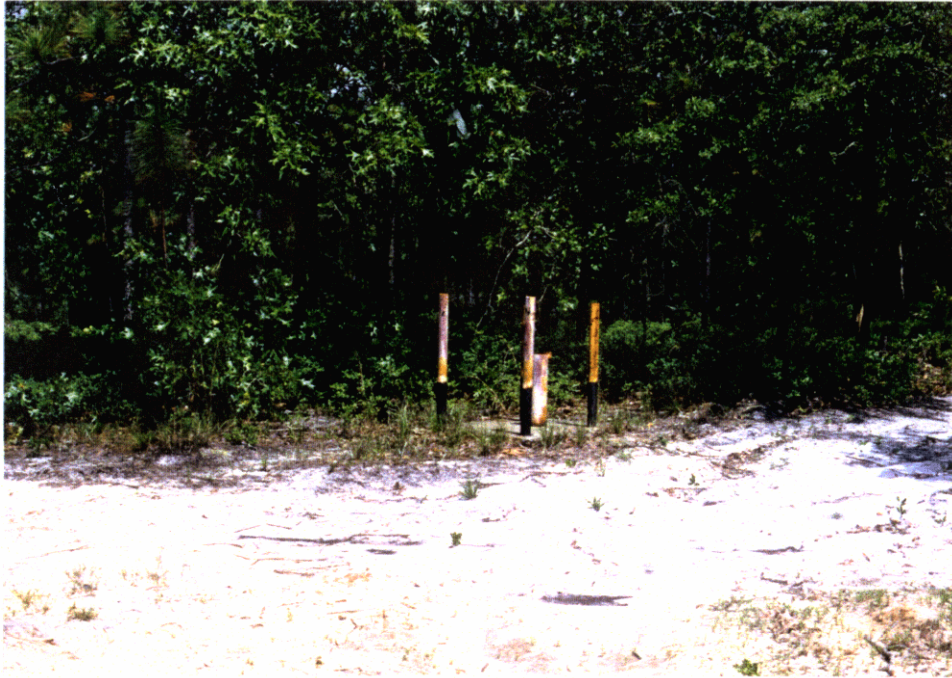
OU7.Site30.1994.03

This photograph depicts the amount of vegetative growth and understory at Site 30. Monitoring well 30-GW01 is pictured in the foreground.

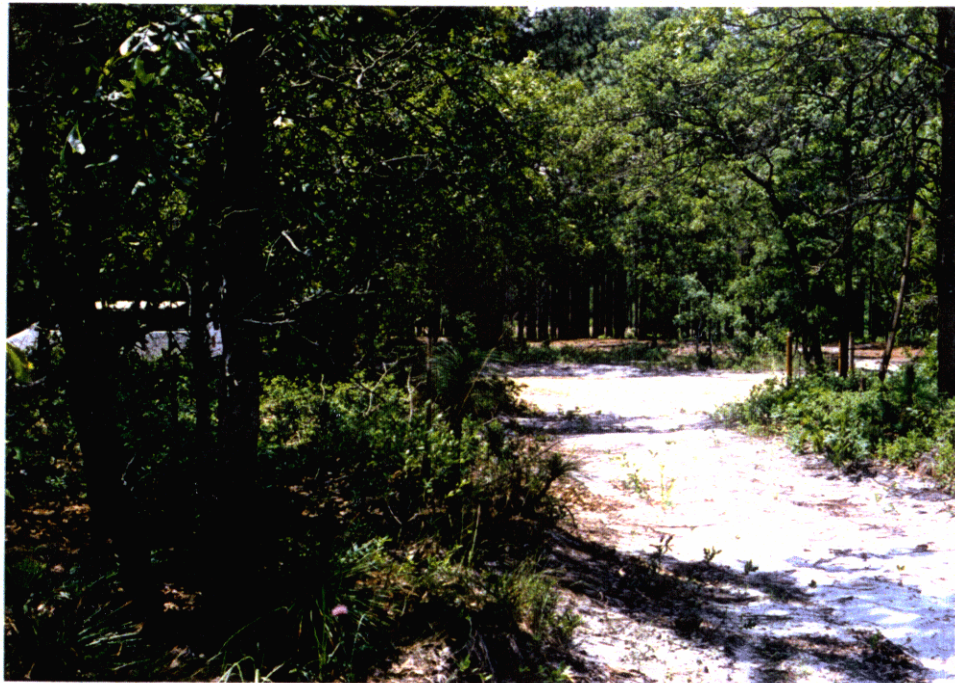
OU7.Site30.1994.04

Facing north toward the site access road, this photograph was taken from within the suspected disposal area.

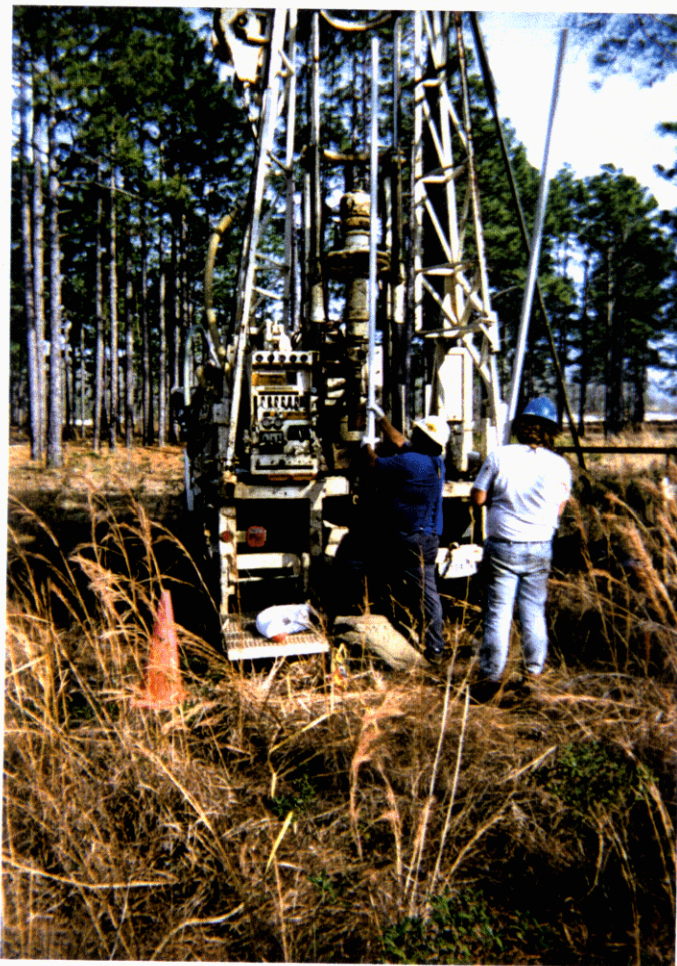
OU7.GW.1994.01:

These personnel are in the process of installing a groundwater monitoring well at Site 30.

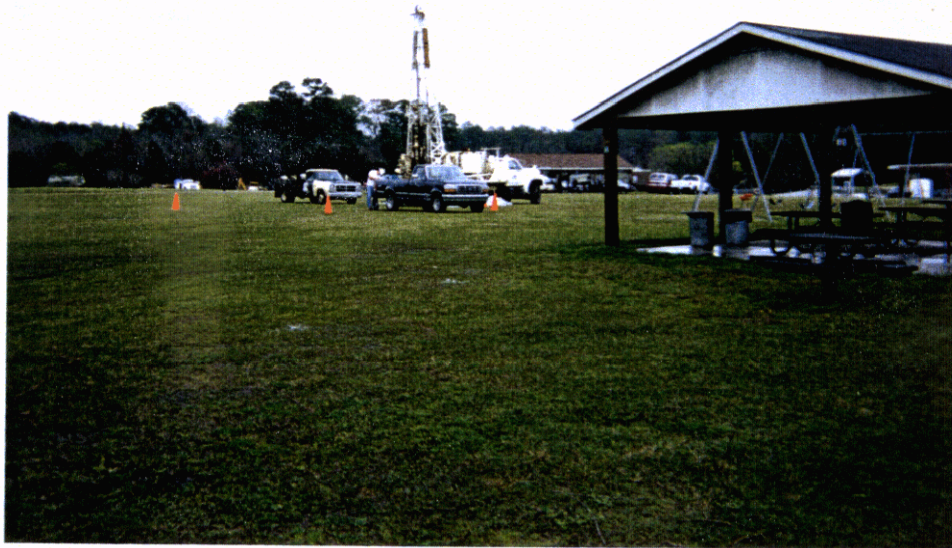
OU7.GW.1994.02: This photograph depicts the installation of a temporary monitoring well, 28-TGWPA, at Site 28. Due to the nature of unconsolidated fill material and buried debris, a permanent well at this location was not feasible.

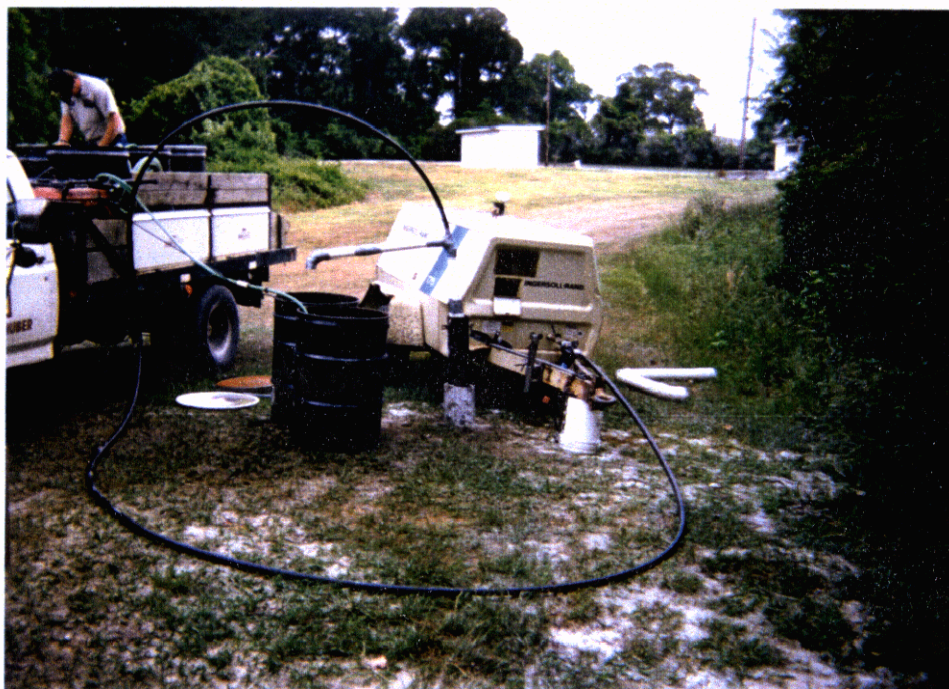
OU7.GW.1994.03: Deep groundwater monitoring wells were developed using the compressed air system pictured here. The high density polyethylene (HDPE) tubing was used once and discarded.

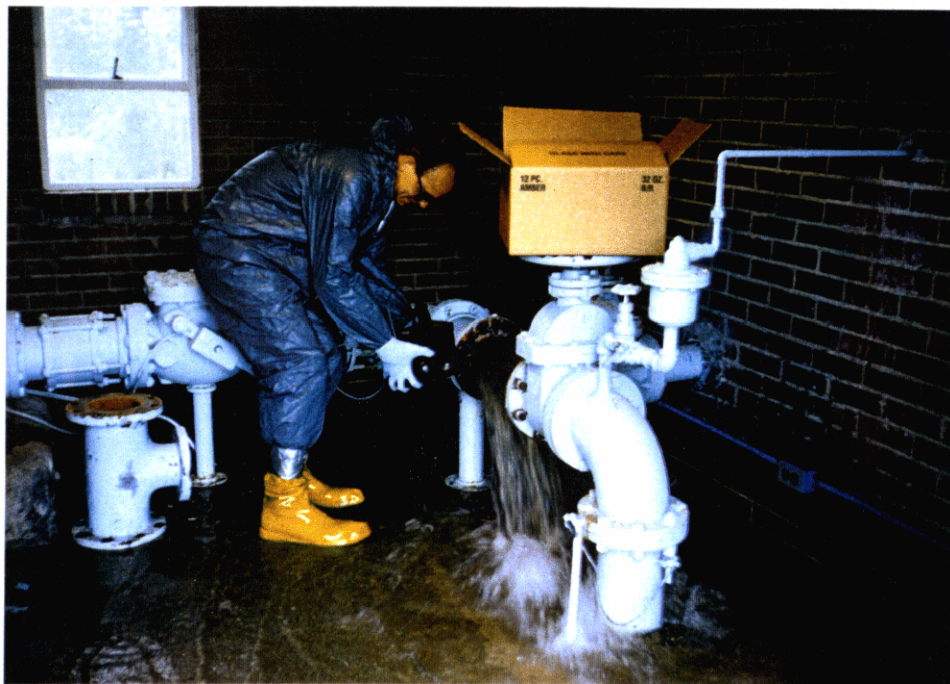
OU7.GW.1994.04: This supply well, 1-HP-638, was sampled as part of the RI. The purge water is being monitored in this photograph for volatile organic compounds using a photoionization detector. Approximately three well volumes were purged in this manner prior to sampling.

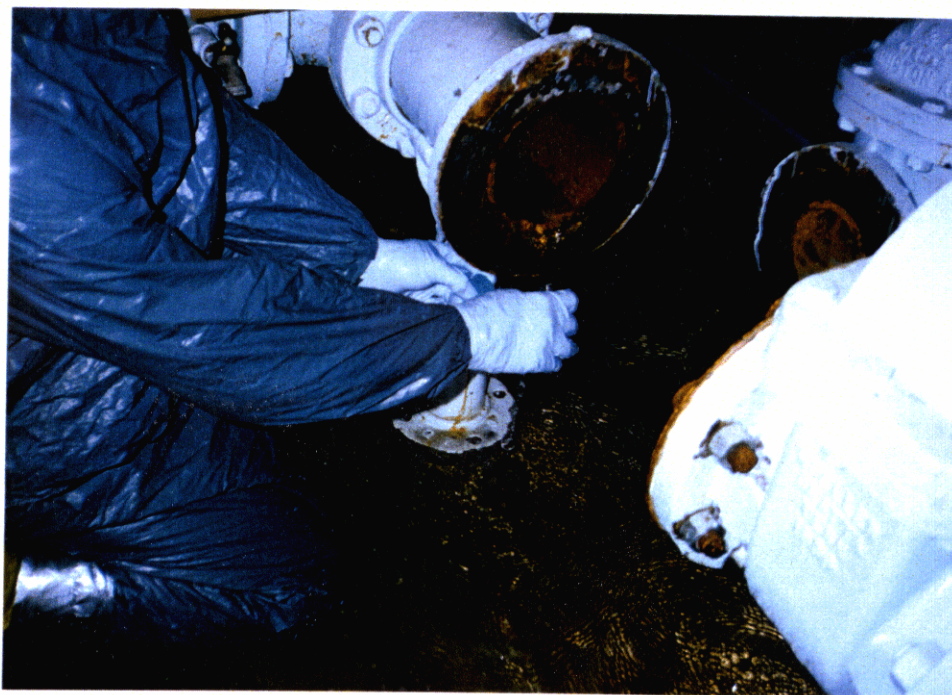
OU7.GW.1994.05: This groundwater sample was collected at 1-HP-638, by reducing the flow velocity. The supply well is currently not connected to the base water system.
